PHYTOTOXICOLOGY
ASSESSMENT SURVEY
OF THE
MAY 1990 FIRE
AT THE
BRANTFORD ONTARIO HYDRO
TRANSFORMER STATION

ARB 019-91-PHYTO

William I. Gizyn
Phytotoxicology Section
Air Resources Branch
Ontario Ministry of the Environment

MARCH 1992

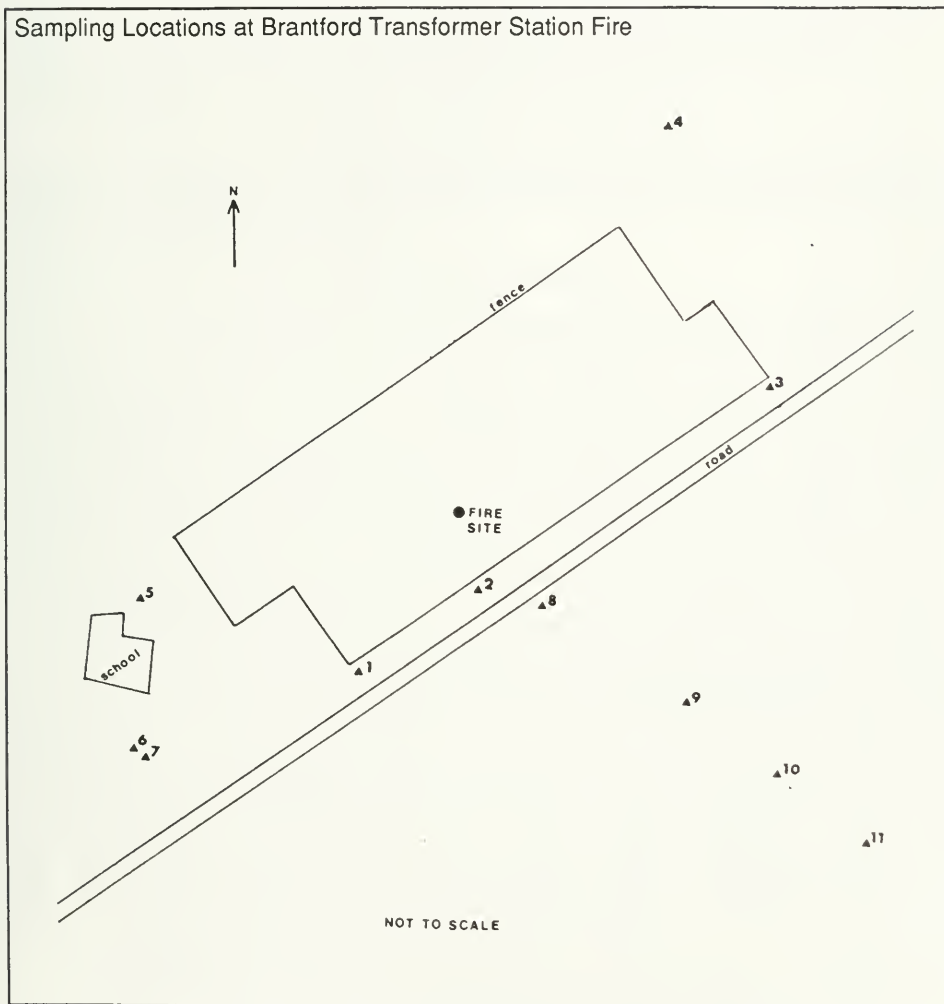
The following sketch map illustrates the relative locations of the school and field to the station and the transformer. This figure also identifies the locations of foliage and soil samples taken during the investigation.
